DOT/FAA/AR-00/13

CAA Paper 99003
Civil Aviation Authority
London, England

Benefit Analysis for Aircraft 16-g Dynamic Seats

April 2000

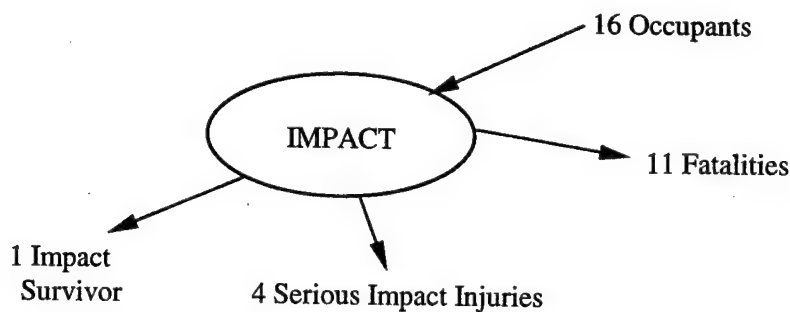
SCENARIO 4

Scenario 4 represents seat row 34 to seat row 40, located at the front of the rear section and subjected to massive disruption of cabin floor, walls, and ceiling. Full details of occupant injury are not known but due to the extent of the cabin disintegration there is unlikely to be any benefit from the introduction of 16-g seats. Therefore the breakdown of injuries will have no bearing on the outcome of this analysis and all fatalities have been assumed to be from impact forces.

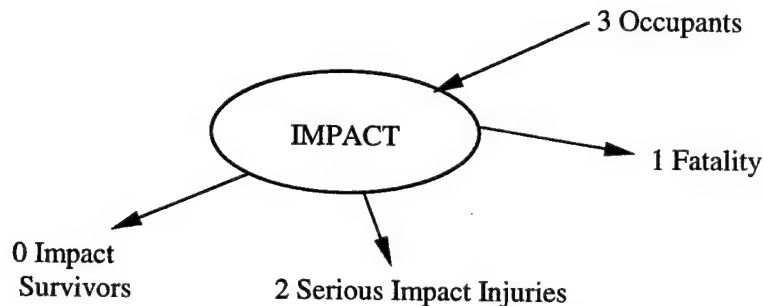
SCENARIO 2

Scenario 2 represents the area occupied by the forward flight attendants, one of whom sustained fatal impact injuries and the remaining two sustained serious impact injuries.

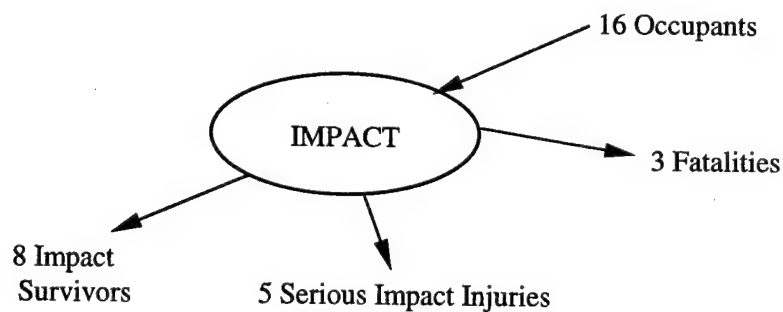
SCENARIO 12

Scenario 12 represents the passenger cabin aft of seat row 36. It is assessed that this portion of the cabin contained 16 occupants of which 3 sustained fatal injuries as a result of impact trauma.

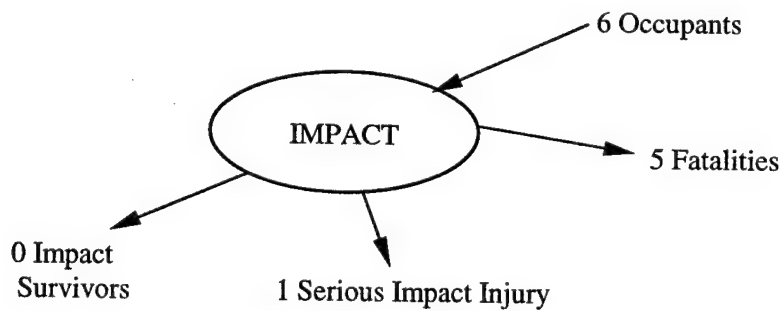
SCENARIO 2

Scenario 2 represents the areas occupied by the flight attendants.

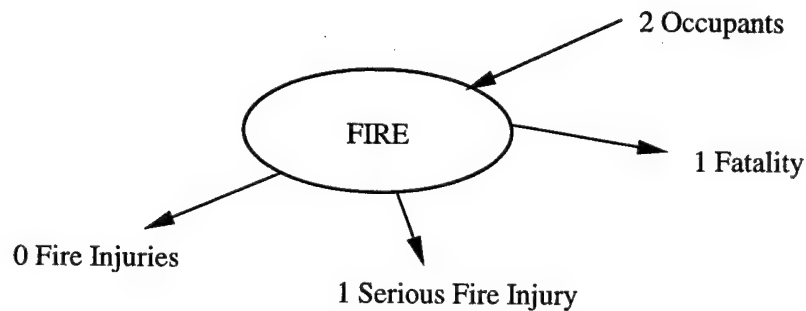
SCENARIO 2

Scenario 2 represents the forward flight attendant area. One flight attendant died of asphyxia due to smoke inhalation and the other suffered serious fire burns.

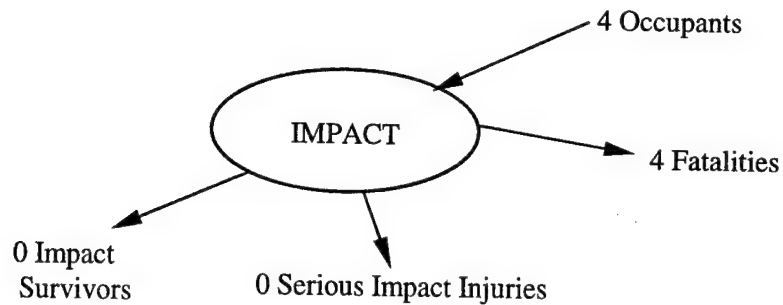
SCENARIO 1

Scenario 1 represents the flight deck and the vestibule area containing two flight crew and two cabin crew. All four crewmembers sustained fatal impact injuries in the impact.

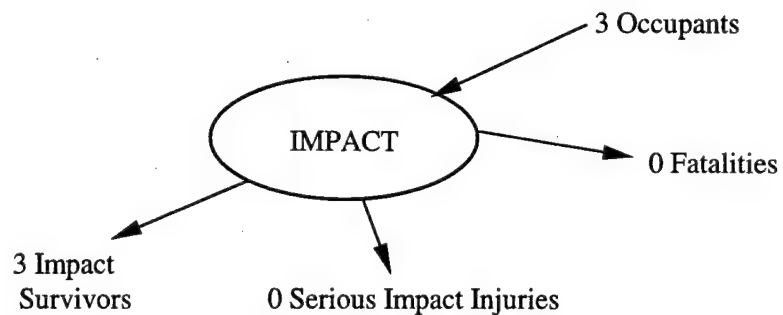
SCENARIO 1

Scenario 1 contains the flight deck area which was subjected to the impact and was not fire damaged. The scenario contains the three flight crew.

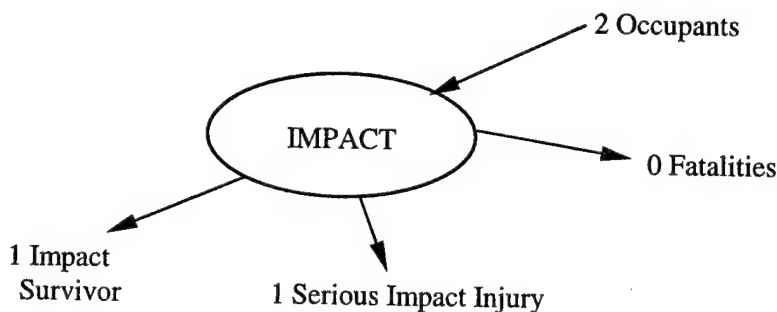
SCENARIO 2

Scenario 2 contains the forward flight attendant area where only the chief steward sustained serious injuries from the impact. The scenario contains two flight attendants.

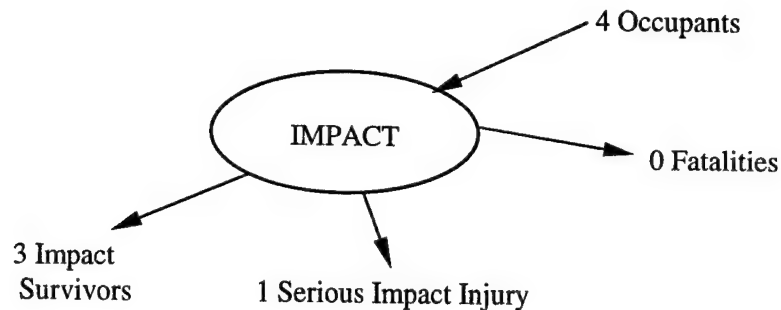
SCENARIO 1

Scenario 1 represents the flight deck and the vestibule area containing two flight crew and two cabin crew. One cabin crewmember sustained serious injuries and the others received minor or no injuries in the impact.
